# ANNUAL REPORT FOR 2002

**White's Store Mitigation Site**

**Project No. 8.T051401**

Prepared By:  
Office of Natural Environment & Roadside Environmental Unit  
North Carolina Department of Transportation  
December 2002

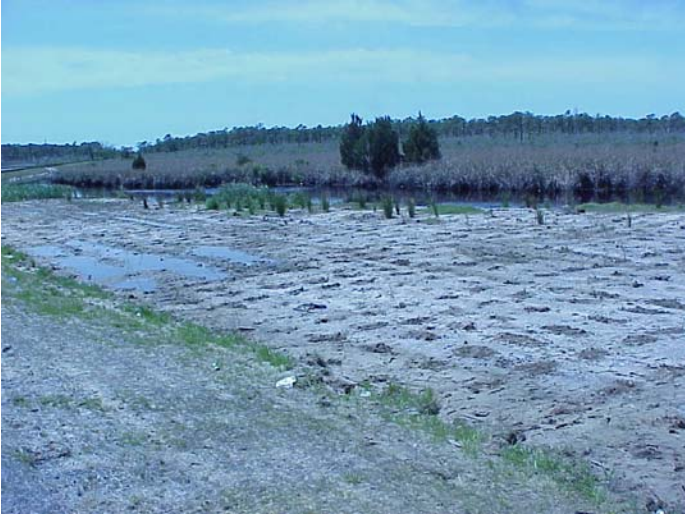
Photo 1

Site was monitored in August 2002 and minimal planted vegetation was observed. Therefore, no values were calculated for frequency and percent cover.

The White's Store site does not currently meet the approved vegetation success criteria. NCDOT plans to conduct soil samples and further evaluate the vegetation failure experienced in 2002. Possible explanation of the lack of vegetation success may be due to problems with the soil present after excavation of the old road bed and/or soil compaction problems from the old road bed. NCDOT plans to perform soil tillage and custom fertilization based on NCDA soil analysis before re-planting. The site is scheduled to be replanted in May, 2003.

Adequate soil preparation and soil amendments will be accomplished prior to replanting. The site was replanted in May 2002, but monitoring conducted in August 2002 indicated minimal plant survival. The site will be re-evaluated and is scheduled to be replanted in 2003. Vegetation monitoring will begin again once the site has been replanted.

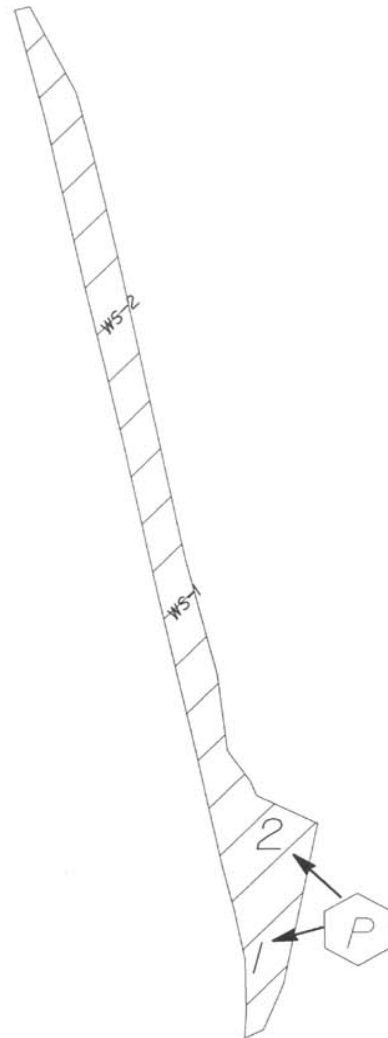
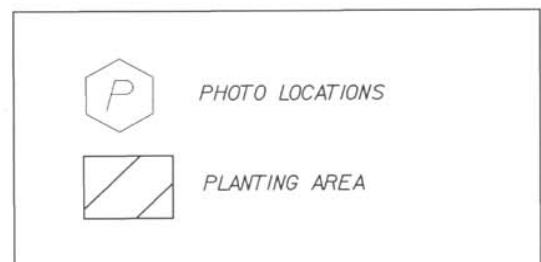
WHITE STORE MITIGATION SITE

Two groundwater gauges monitor water levels on the site. Since no rain gauge was installed on the site, rainfall measured at the nearby Mashoes Road Mitigation Site is included on the final groundwater measurement plots to see how the site responds to individual rainfall events. The vegetation plot map included in Appendix B contains the locations of the two site groundwater gauges.
